DEPARTMENT OF TRANSPORTATION

Contract #: 04-0120F4Cty: SF/ALA Rte: 80 PM: 13.2/13.9File #: 99.28**WELDING INSPECTION REPORT****Resident Engineer:**Siegenthaler, Peter**Address:** 333 Burma Road**City:** Oakland, CA 94607**Report No:** WIR-021837**Date Inspected:** 18-Mar-2011**Project Name:** SAS Superstructure**OSM Arrival Time:** 700**Prime Contractor:** American Bridge/Fluor Enterprises, a JV**OSM Departure Time:** 1900**Contractor:** Zhenhua Port Machinery Company, Ltd (ZPMC), Changxing Island **Location:** Shanghai**CWI Name:** Tian Lei, Liu Fa Wen**CWI Present:** Yes No**Inspected CWI report:** Yes No N/A**Rod Oven in Use:** Yes No N/A**Electrode to specification:** Yes No N/A**Weld Procedures Followed:** Yes No N/A**Qualified Welders:** Yes No N/A**Verified Joint Fit-up:** Yes No N/A**Approved Drawings:** Yes No N/A**Approved WPS:** Yes No N/A**Delayed / Cancelled:** Yes No N/A**Bridge No:** 34-0006**Component:** OBG**Summary of Items Observed:**

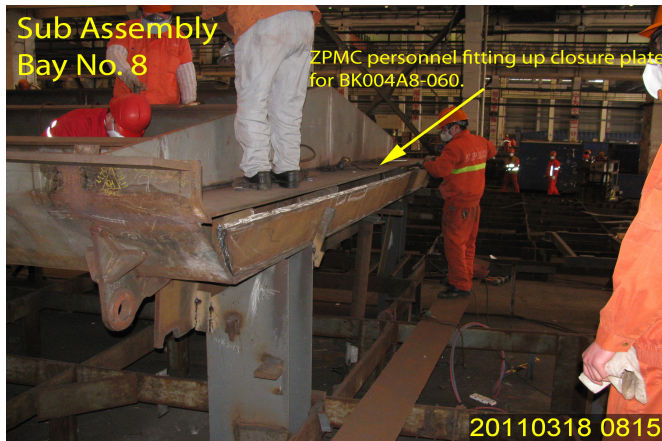
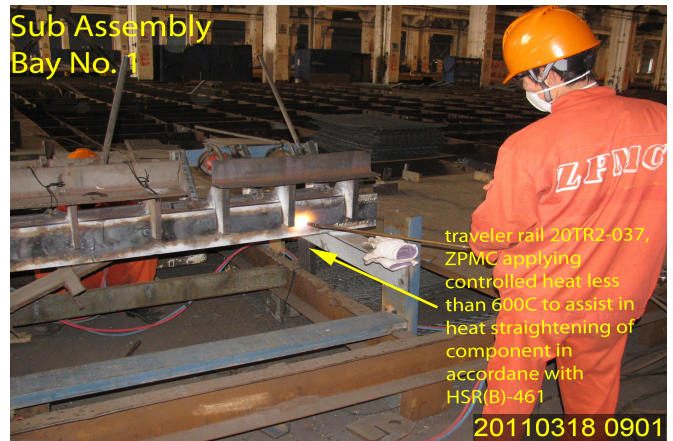
Unless otherwise noted above all items observed on this day appeared to be in general compliance with the applicable contract documents
